# **SULLIVAN COUNTY UNITY COMPLEX BUILDING ASSESSMENT**

## **PHASE ONE ARCHITECTURAL AND STRUCTURAL EVALUATION**

**SULLIVAN COUNTY NH – BOARD OF COMMISSIONERS**

**26 August 2005**

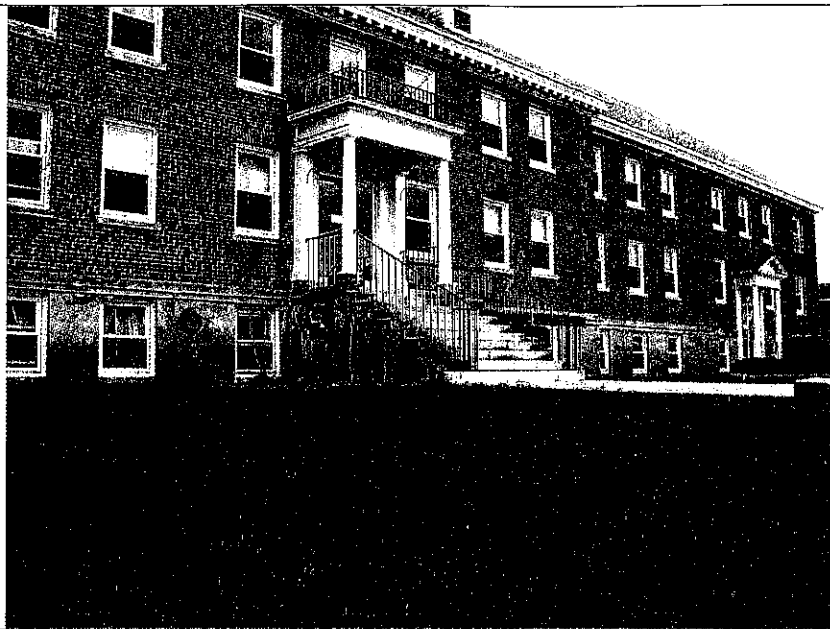
**Photograph A3** – 04/28/05 – Sanders Building (Building #3): Main entry, note damage to exterior steps. Tunnel access is below the main stairs connecting to Maple Hill and beyond to the Carpenters Shop.

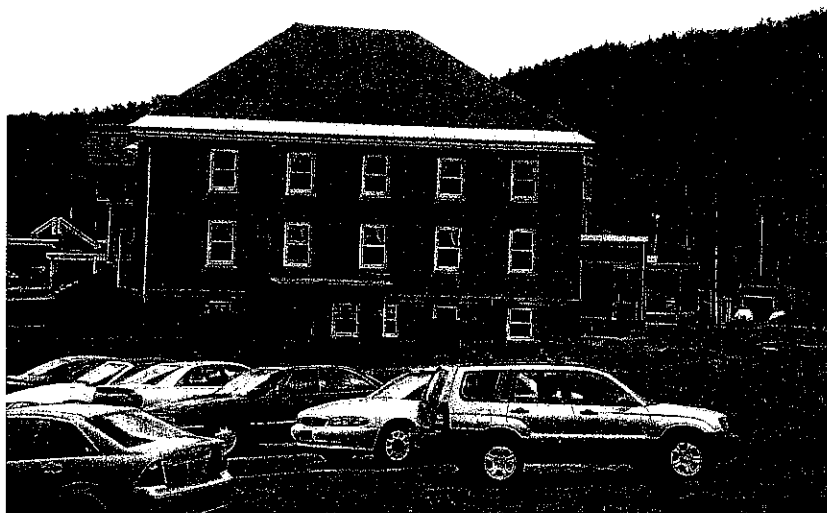
**Photograph A4** - 04/28/05 – Sanders Building (Building #3): West elevations showing the service entrances on the rear of the building.

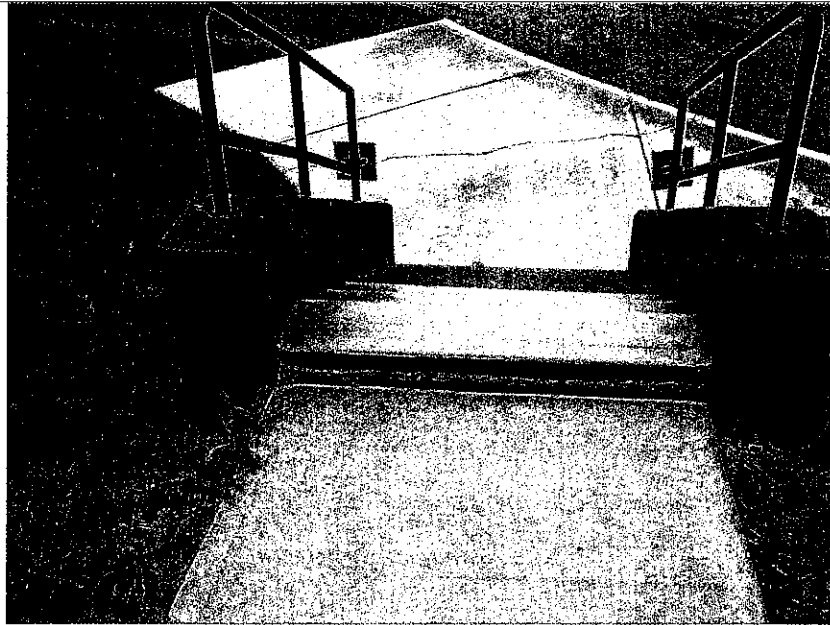
**Photograph A6** - 04/28/05 – Sanders Building (Building #3): Concrete sidewalk is failing.

will remedy this issue. Concrete sidewalks must be repaired to be level with concrete stairs. Additional handrails and guard rails would need to be added to the staircases for code compliance. *See photo A5, A6 and A7.*

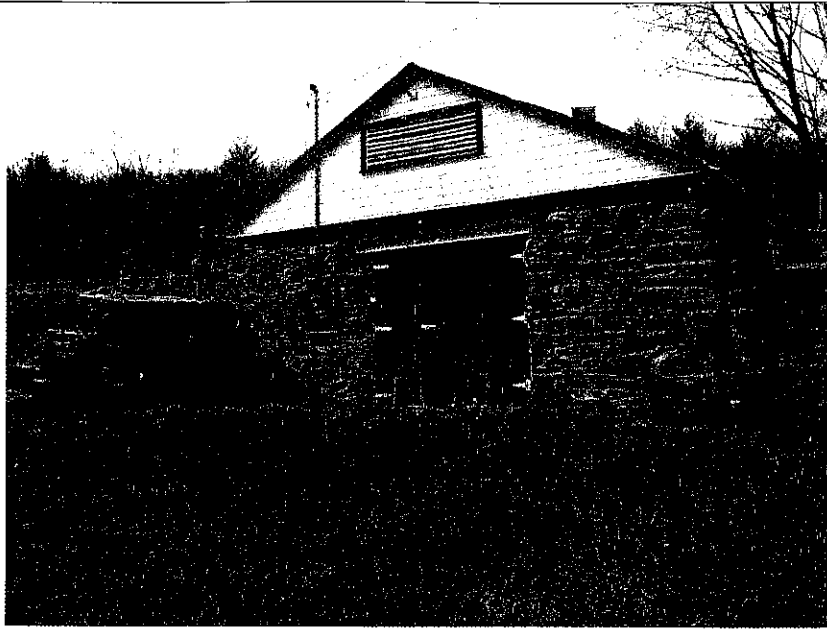
**Photograph 15** – 04/27/05 – Root Cellar (Building #4): Wood end wall needs repairs.

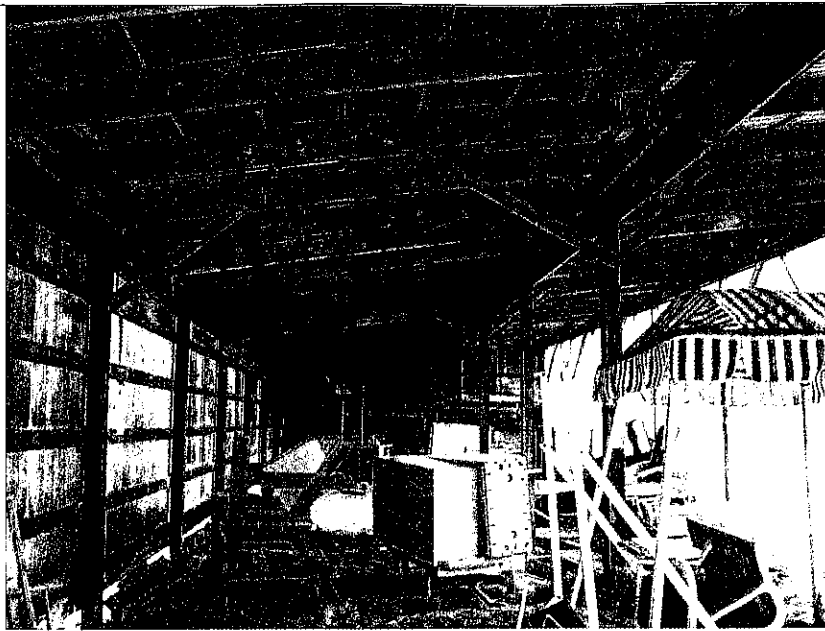
**Photograph A35** – 04/27/05 – Pole Barn II (Building #12): Deteriorating structure of Pole Barn II

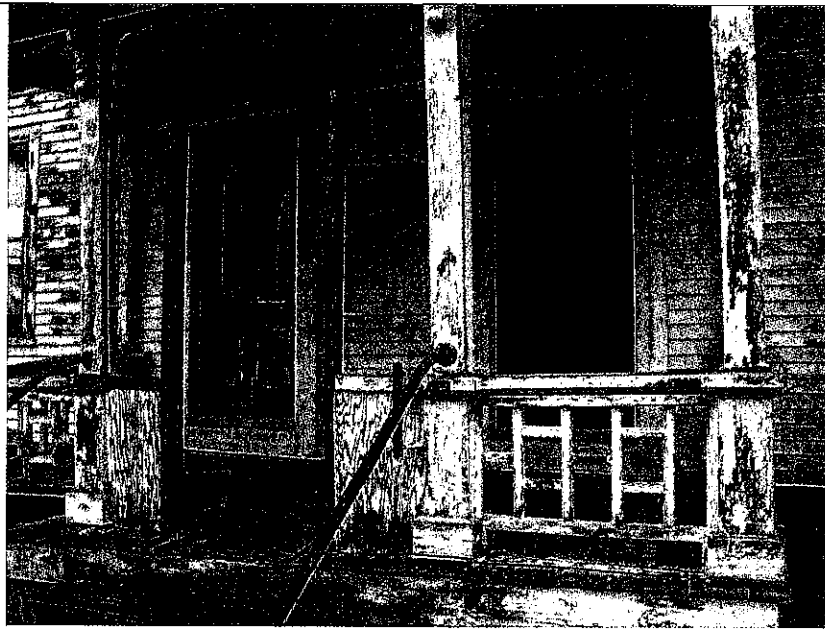
Access to the building is from a main porch to the first floor. The porch is in disrepair and is structurally pulling away from the building. The flooring and stairs would have to be rebuilt with handrails and guardrails to meet code. On the rear of the building there is a exterior storage building addition that is structurally failing. The roof of the addition is the structure for a fire stair to the upper levels that would have to be reconstructed as a means of egress. The storage addition would have to be demolished. The wood siding is in desperate need of paint and repair. *See photo A38, A39 and A40.*

**Photograph 38** – 04/27/05 – Men's Annex (Building #15): Front entry porch failing.

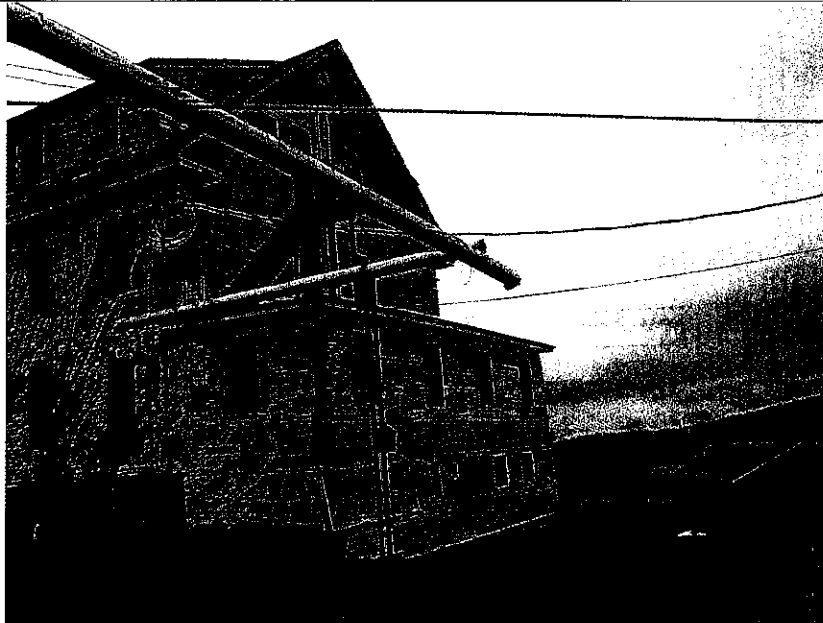
**Photograph 40** – 04/27/05 – Men's Annex (Building #15): rear elevation showing failing structure of addition and broken overhead steam line.

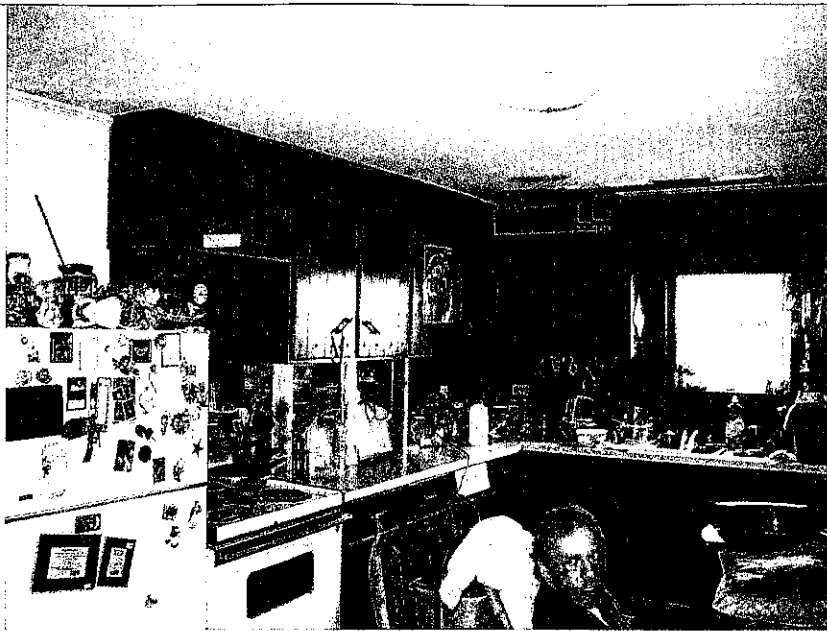
**Photograph 57** - 04/27/05 - Apartment Building (Building #19): Water damage in ceiling from plumbing problems.

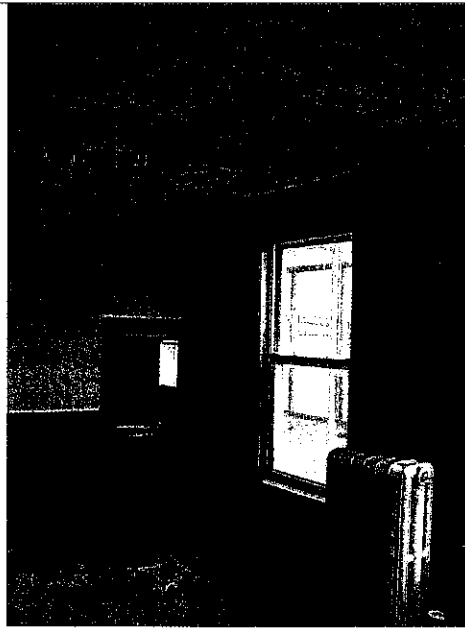
**Photograph 62** - 04/27/05 – Maple Hill (Building #20): First floor damage from water.

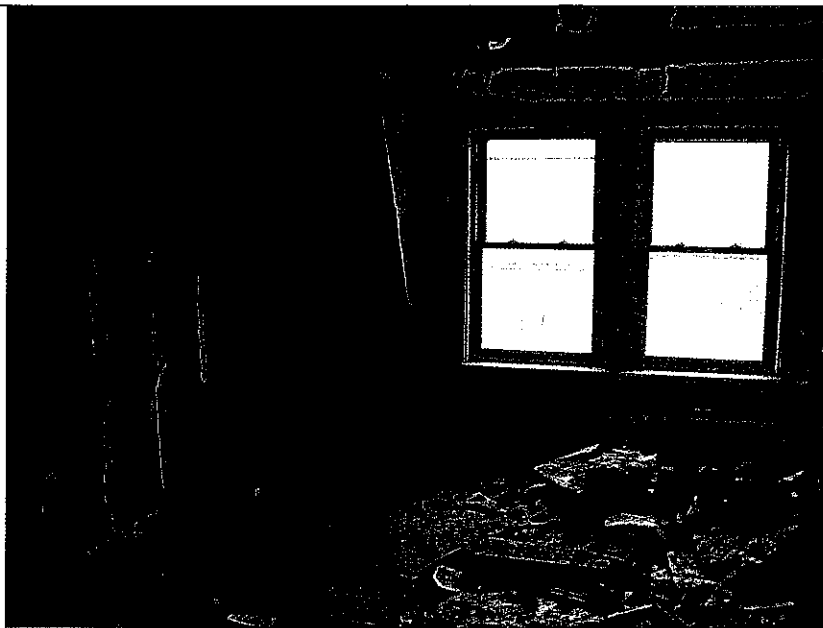
**Photograph 64** - 04/27/05 – Maple Hill (Building #20): Third floor with damage from fire.

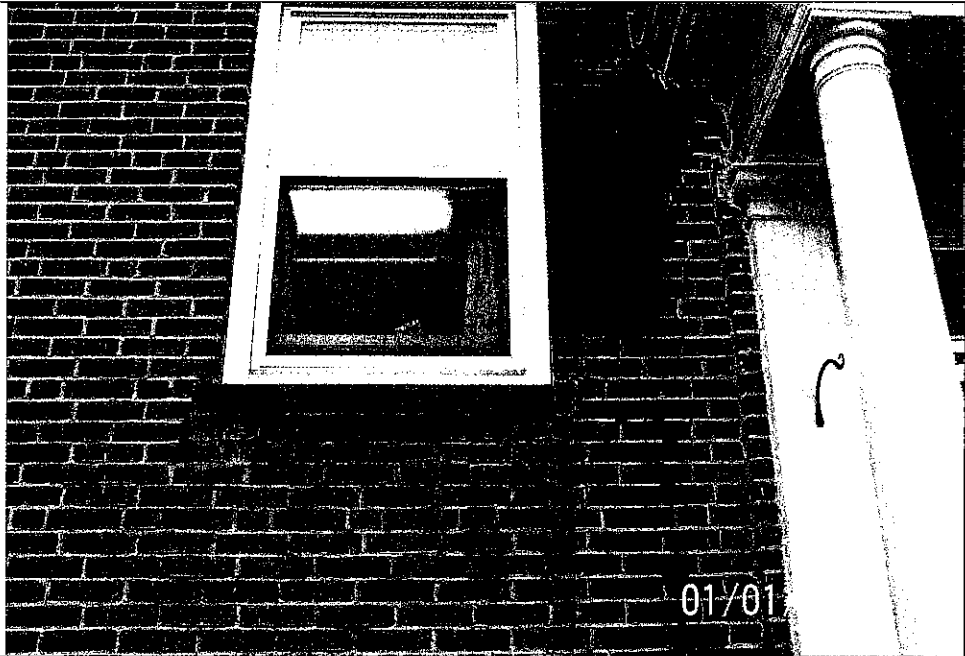
**Photograph 4** - 04/28/05 – Sanders Building (Building #3): Exterior Brick façade: repointing required below window at this location

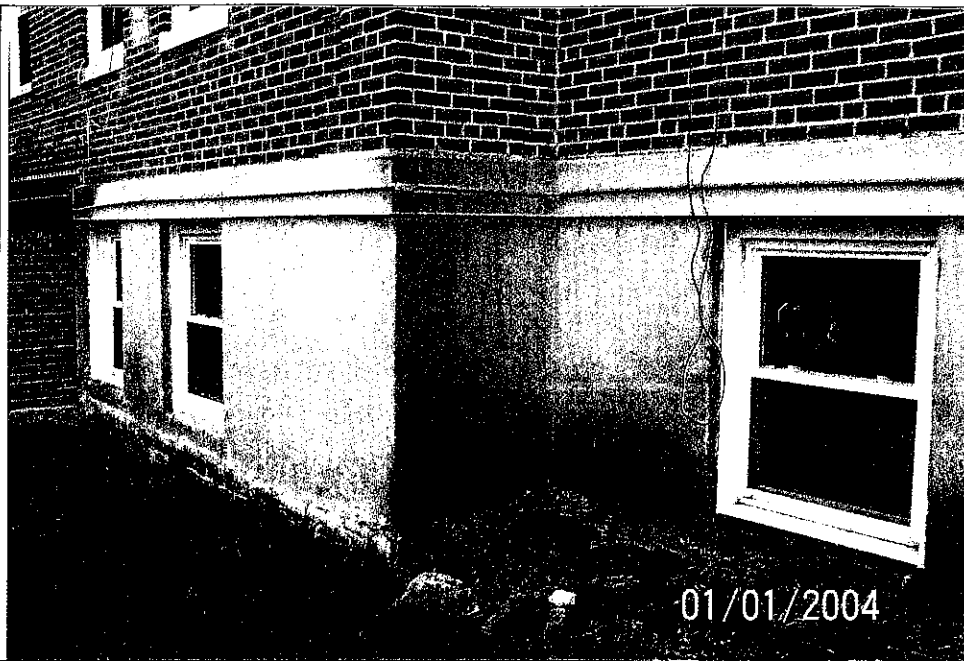
**Photograph 5** – 04/28/05 – Sanders Building (Building #3): Front concrete lower walls surrounding windows- spalling concrete has exposed steel reinforcement

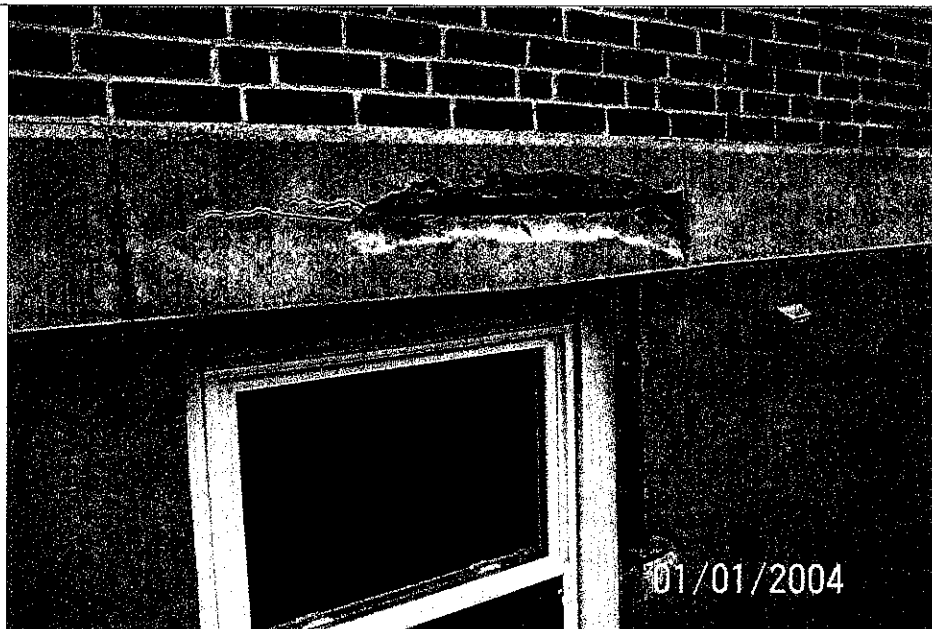
**Photograph 6** – 04/28/05 – Sanders Building (Building #3): Concrete lower walls surrounding window- spalling concrete has exposed steel reinforcement

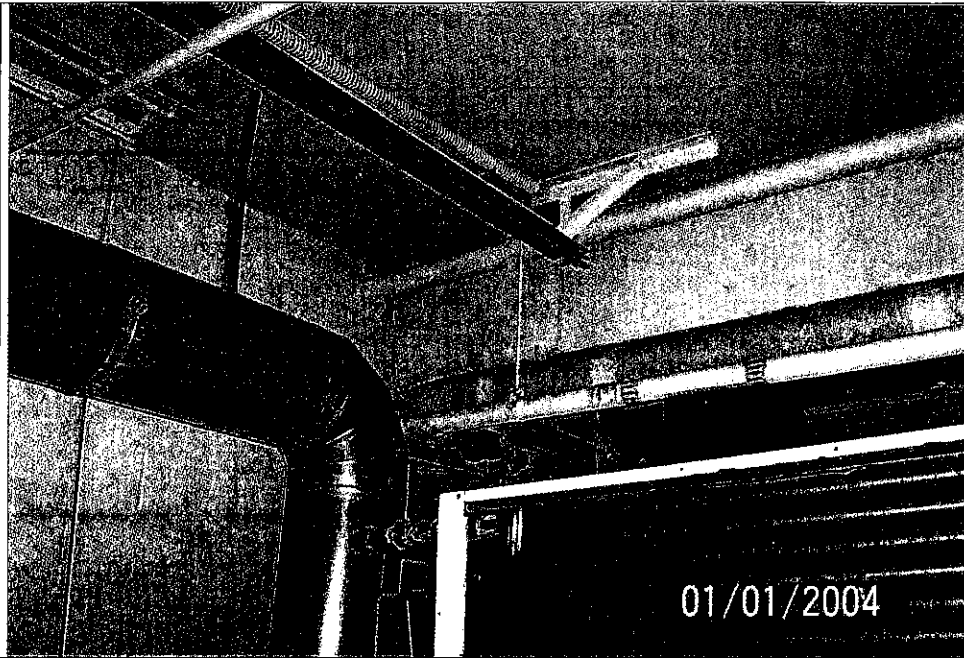
**Photograph 7** - 04/28/05 - Sanders Building (Building #3): 1<sup>st</sup> floor beam is cracking at bearing

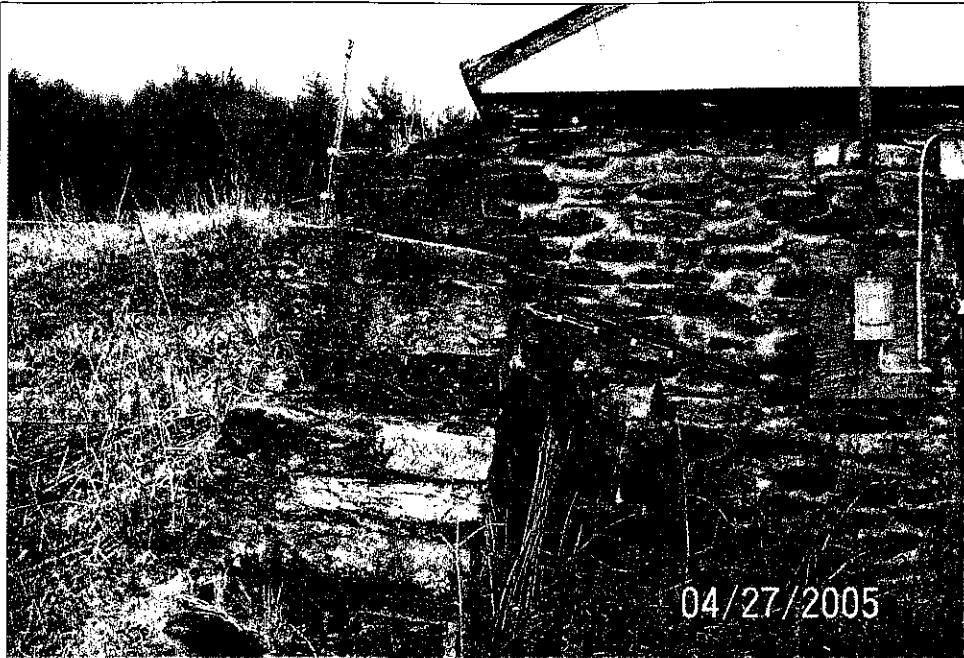
**Photograph 12** – 04/28/05 – Root Cellar (Building #4): Retaining wall #1 is unstable

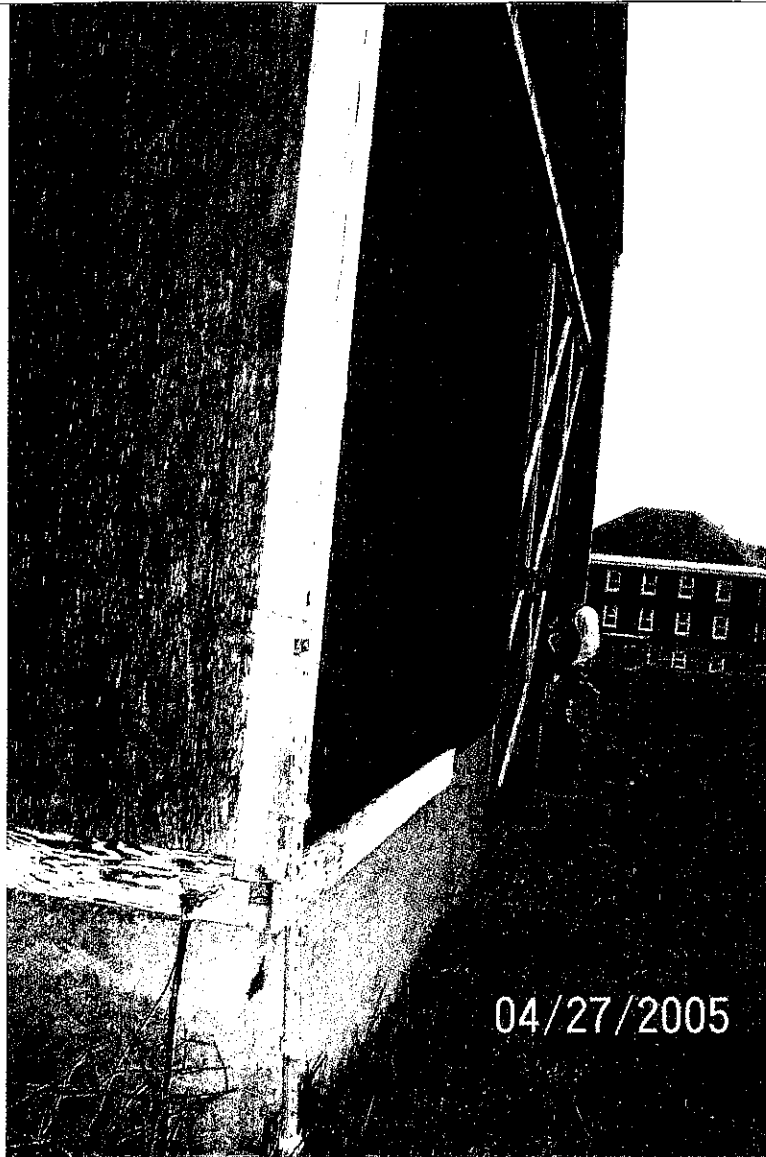
**Photograph 14** – 04/27/05 – Hay Barn (Building #5): Rear wall is slightly bowing outward

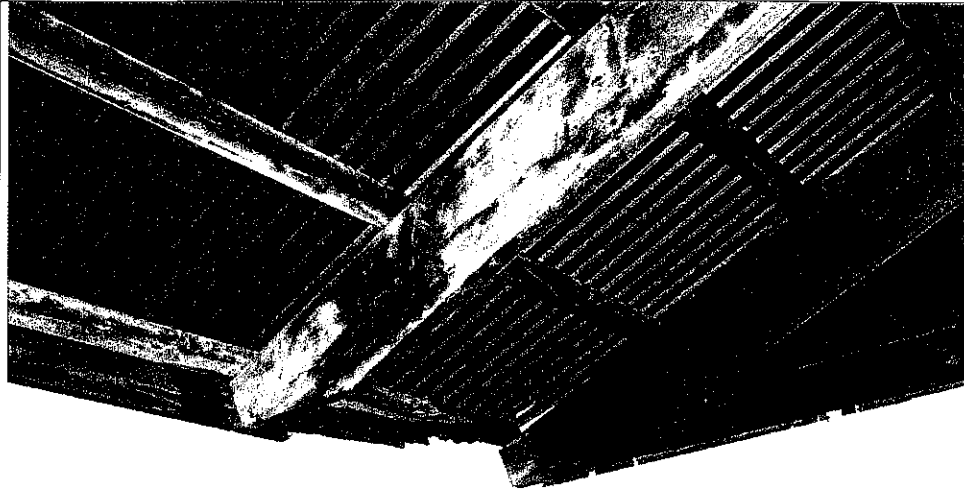
**Photograph 15** – 04/27/05 – Heifer Barn (Building #6): Decayed wooden edge beam

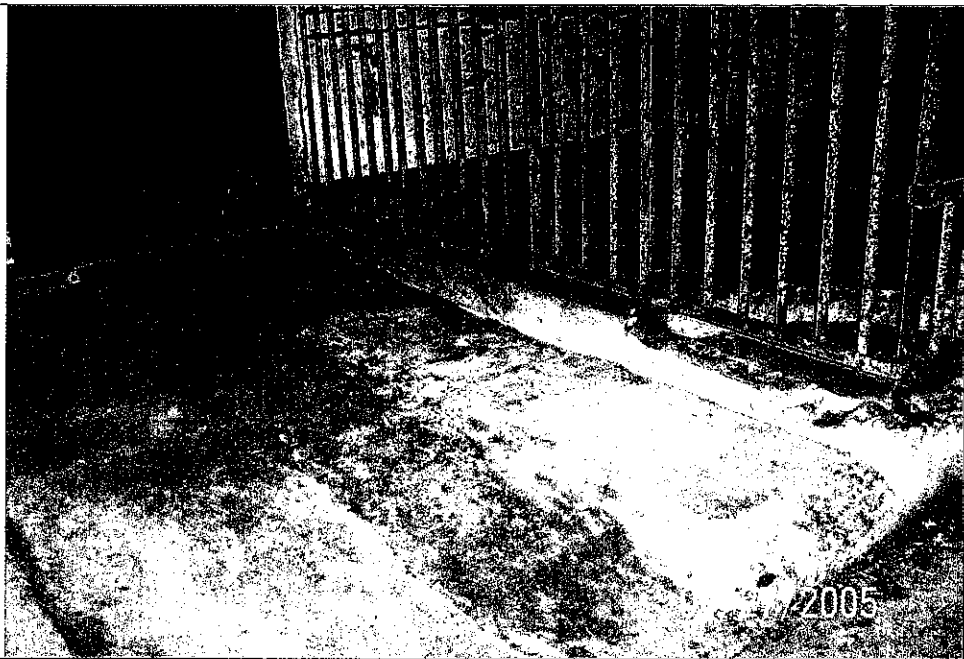
**Photograph 18** - Pig Barn (Building #7): spalling of concrete slab

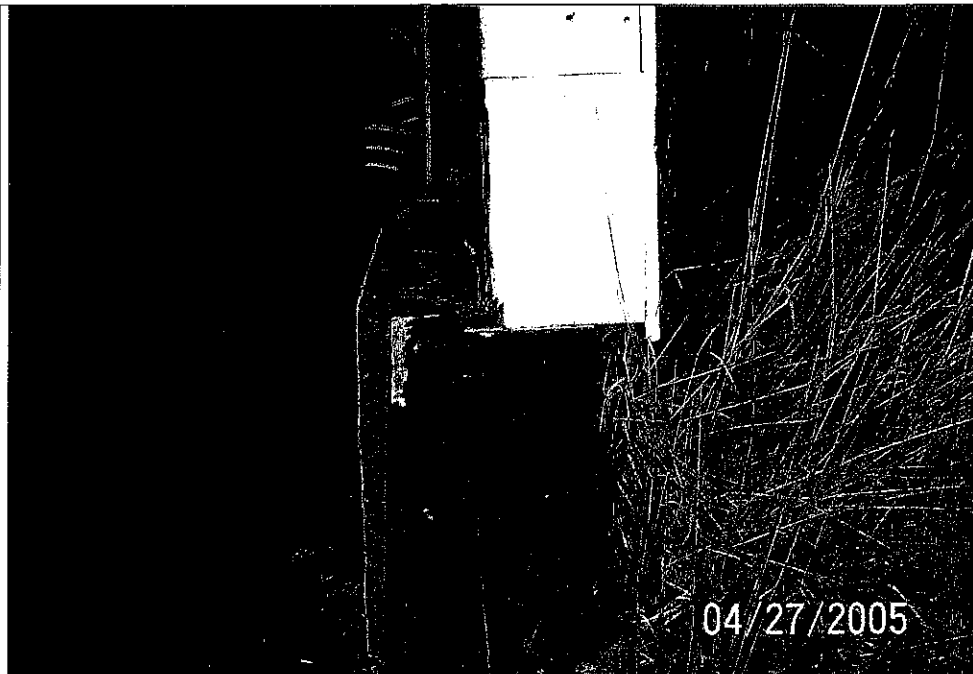
**Photograph 20** - 04/27/05 – Pole Barn I (Building #8): wood post partially bearing on concrete knee wall below

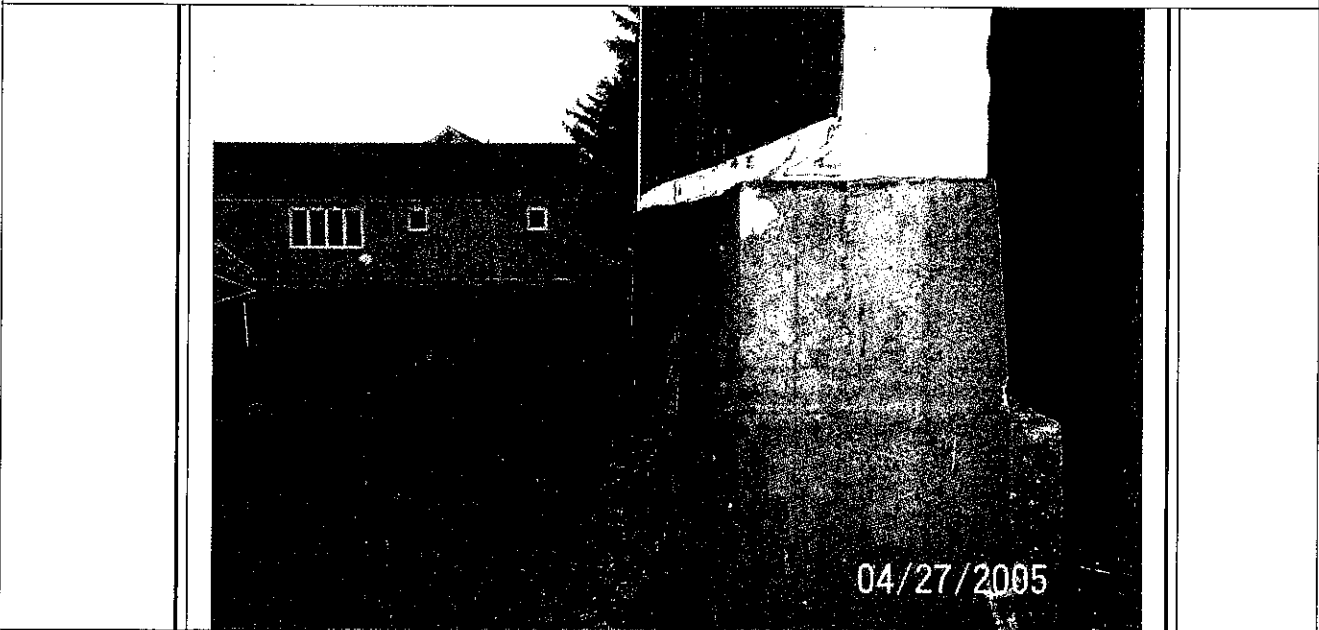
**Photograph 22** - 04/27/05 – Pole Barn I (Building #8): cracks and spalling in concrete foundation knee wall due to settlement

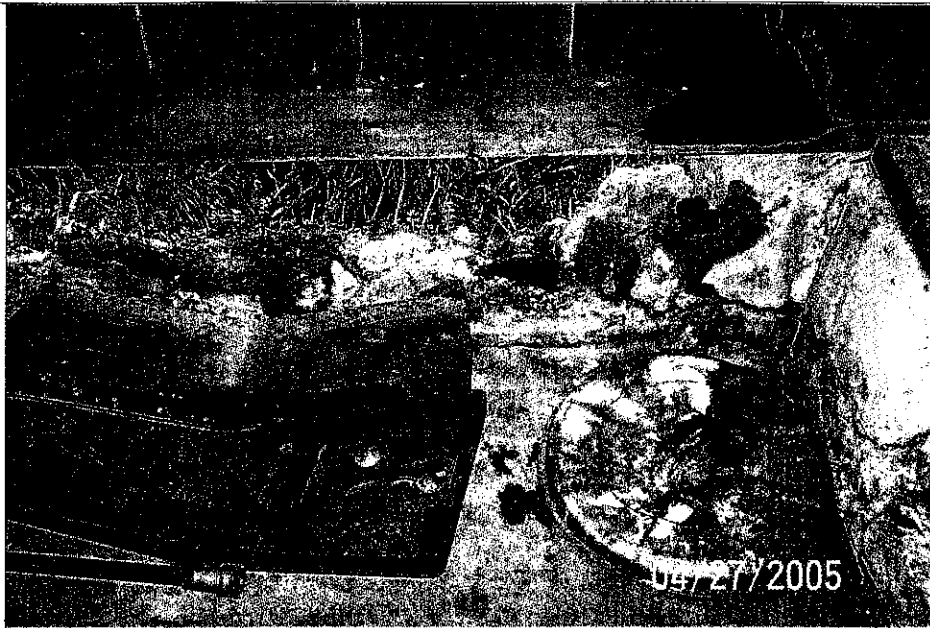
**Photograph 23** – 04/27/05 – Tractor Building (Building #9): Deteriorated concrete foundation wall

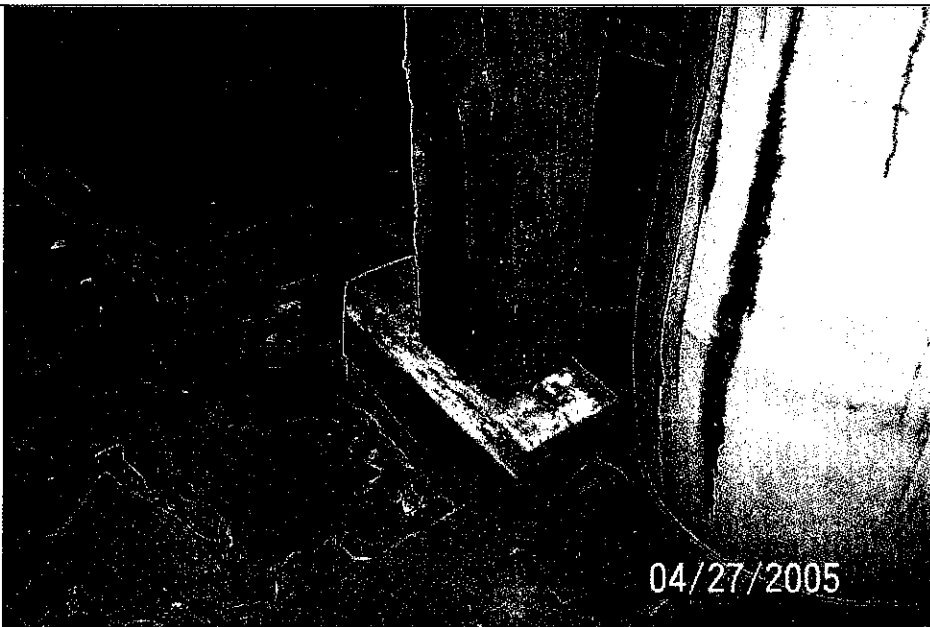
**Photograph 24** - 04/27/05 – Tractor Building (Building #9): Post bearing at open portion of building; cracked slab-on-grade

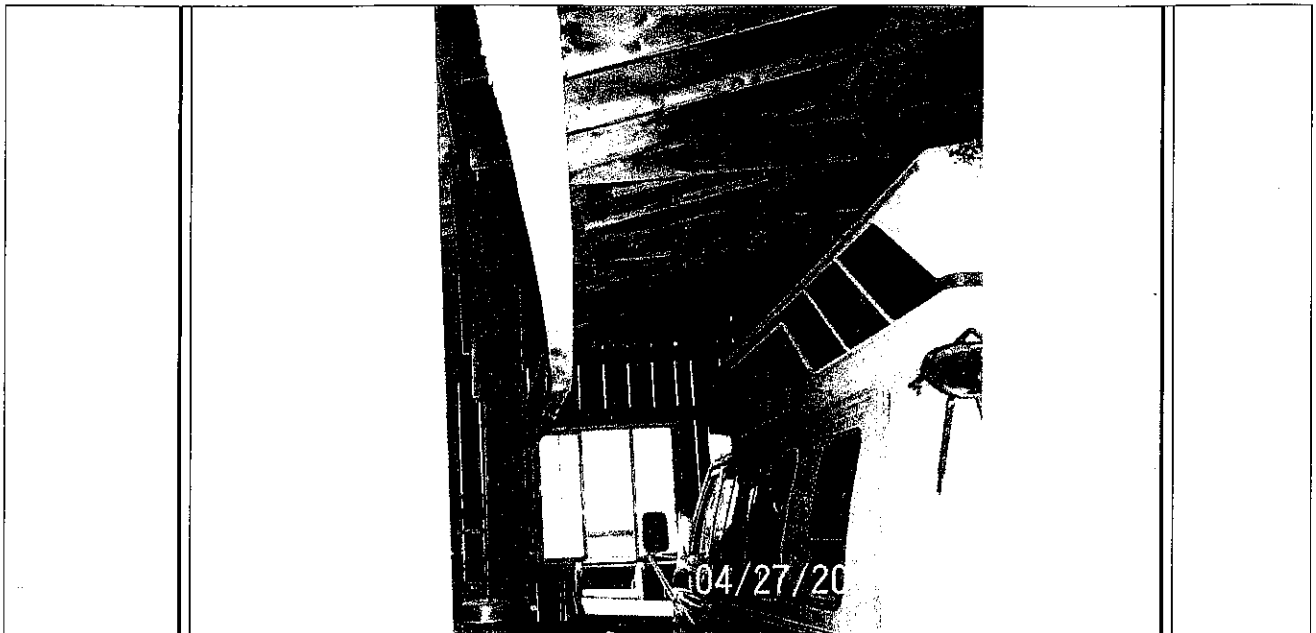
**Photograph 25** – 04/27/05 – Tractor Building (Building #9): Buckled wood beam at closed portion of building

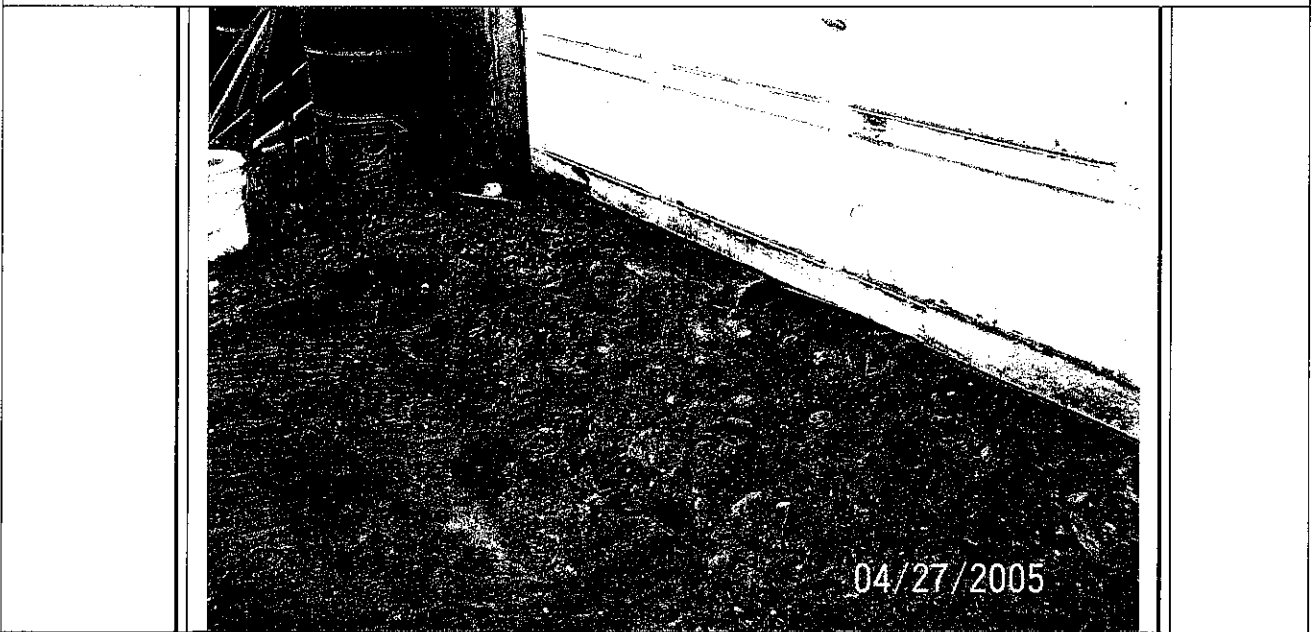
**Photograph 26** - 04/27/05 – Tractor Building (Building #9): Water damage at exterior soil, interior slab-on-grade

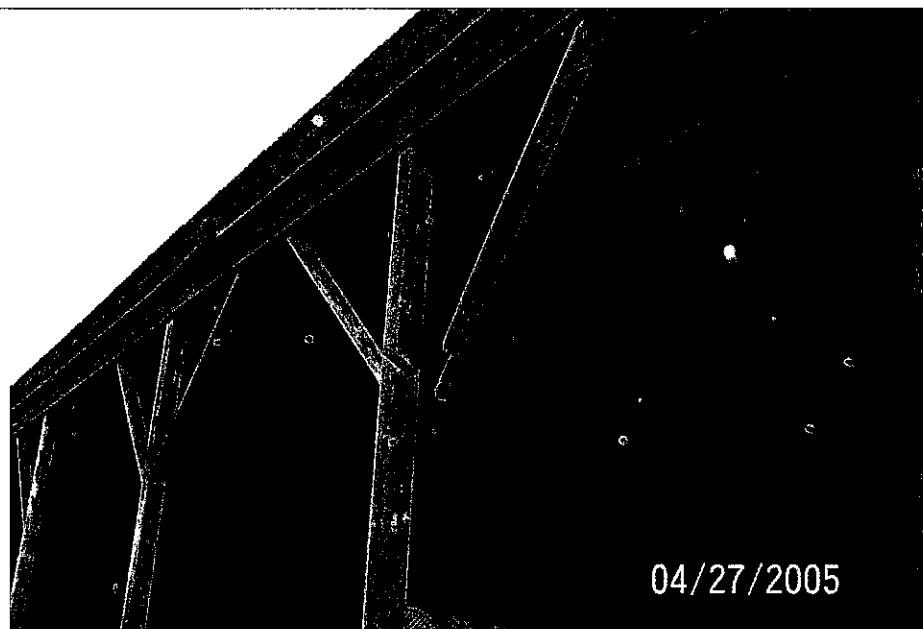
**Photograph 28** - 04/27/05 – Pole Barn II (Building #12): wood knee braces are broken

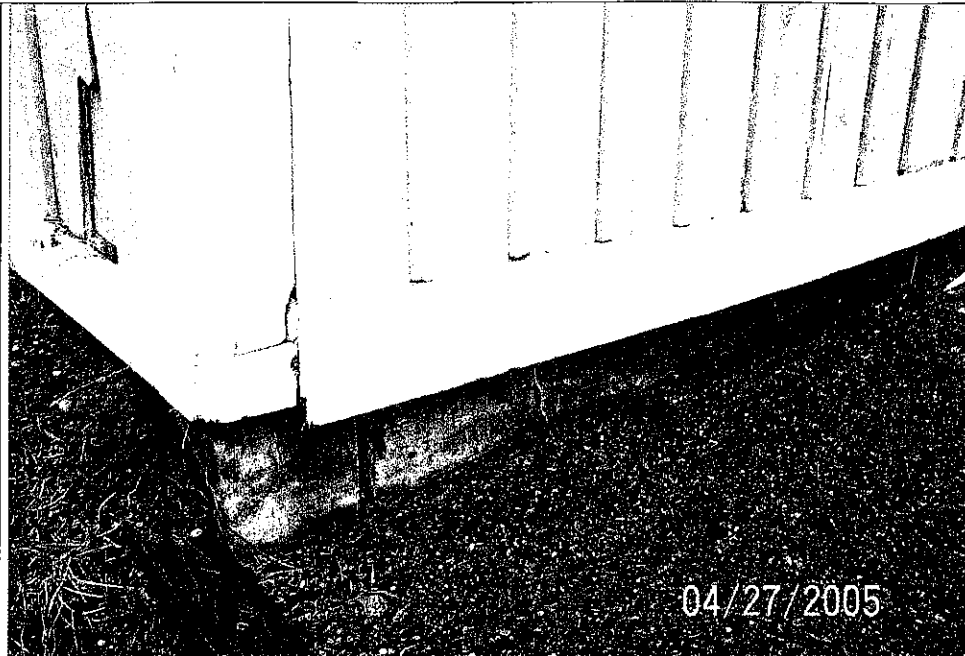
**Photograph 29** – 04/27/05 – One-Car garage (Building #13): Soil erosion undermining foundation

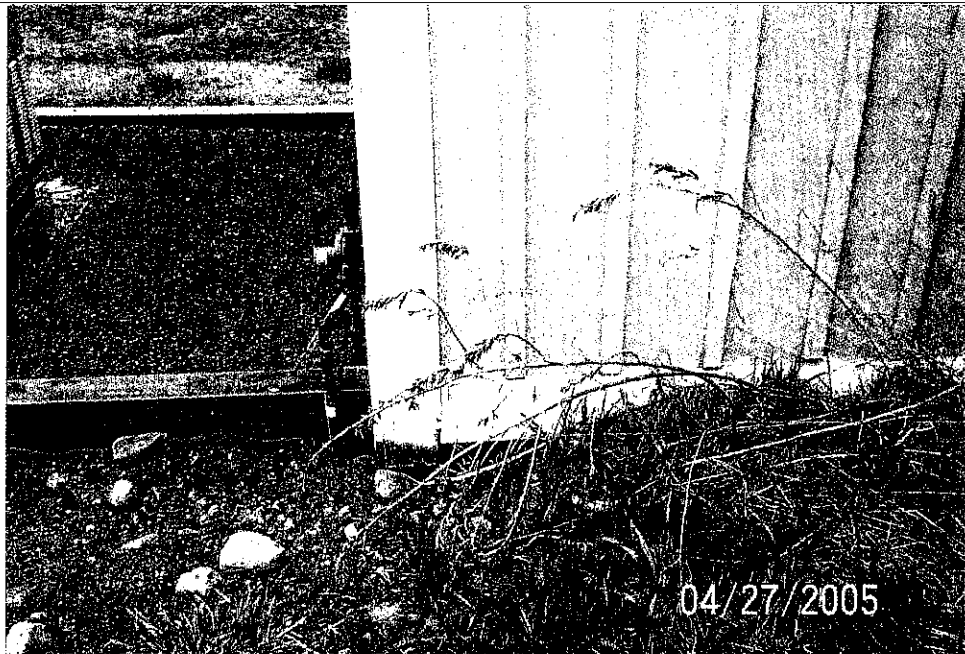
**Photograph 30** – 04/27/05 – One-Car garage (Building #13): Soil erosion undermining foundation

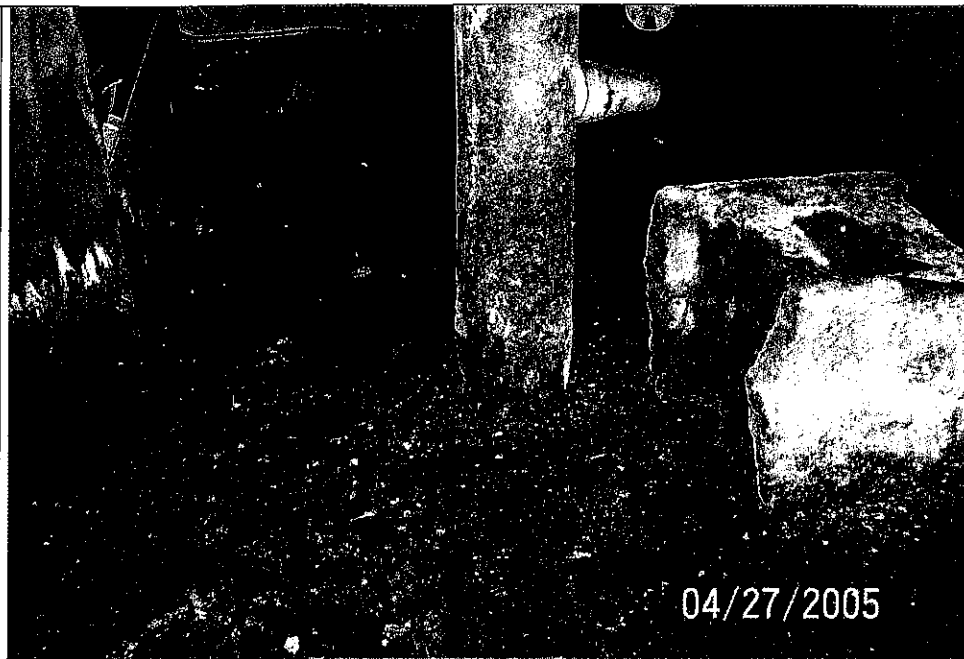
**Photograph 35** – 04/27/05 –Carpenter's Shop (Building #16): Steel post in basement has extensive water damage; slab also has extensive water damage

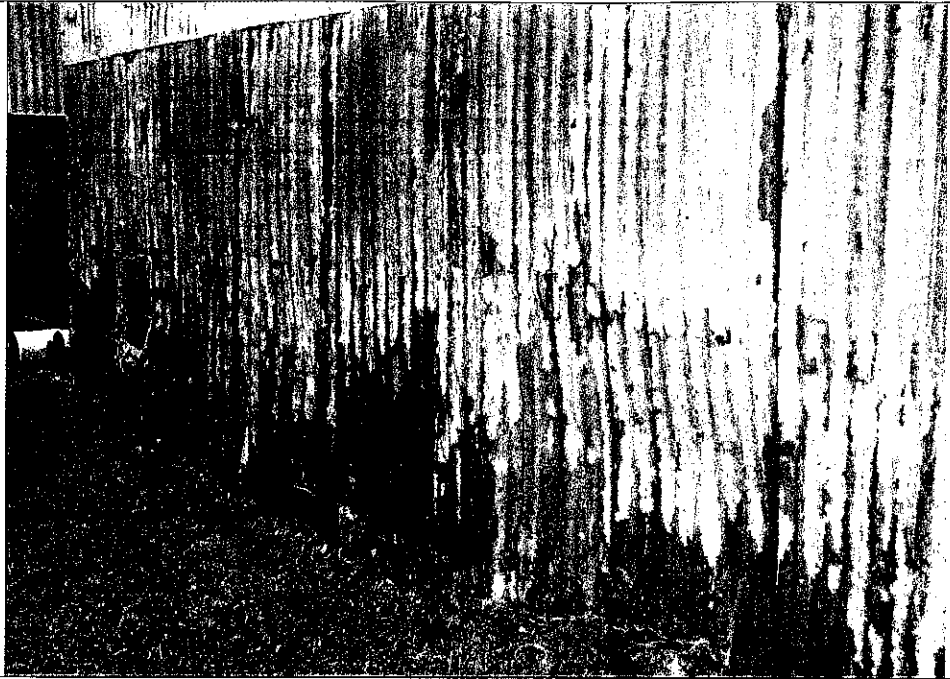
**Photograph 39** – 04/27/05 –Two Car Garage (Building #17): Deterioration of sheet metal façade

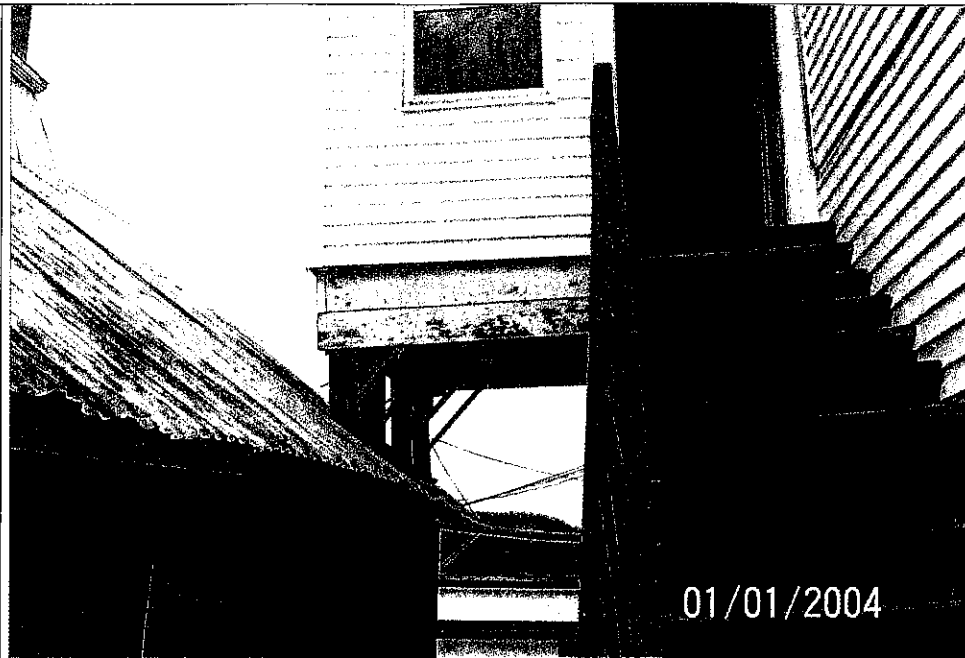
**Photograph 41** – 04/27/05 –Two Car Garage (Building #18): Adjacent porch bearing on garage roof

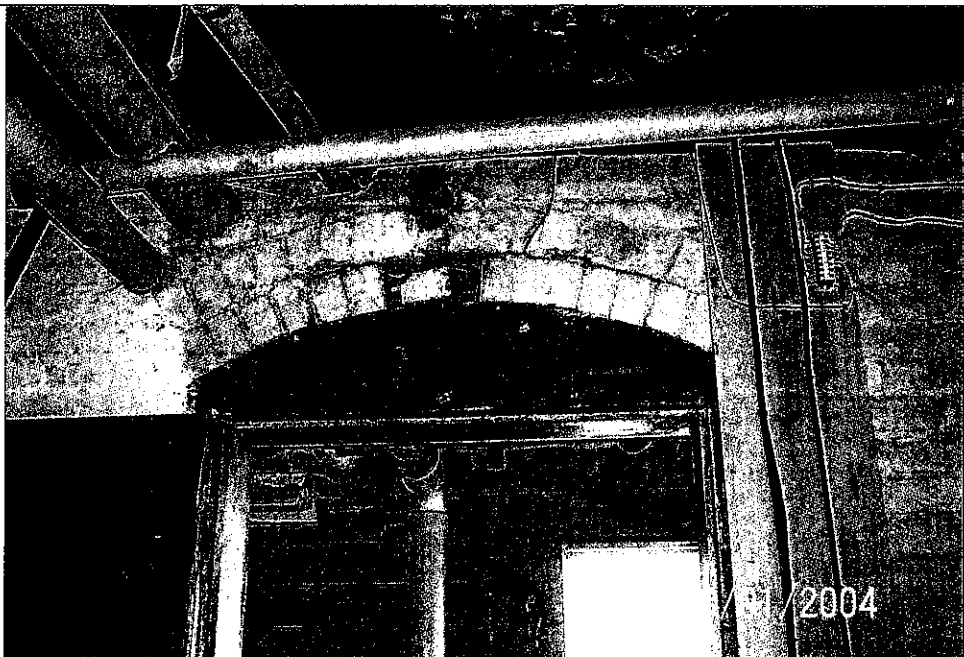
**Photograph 48** - 04/27/05 – Apartment Building (Building #19): Damaged masonry arch

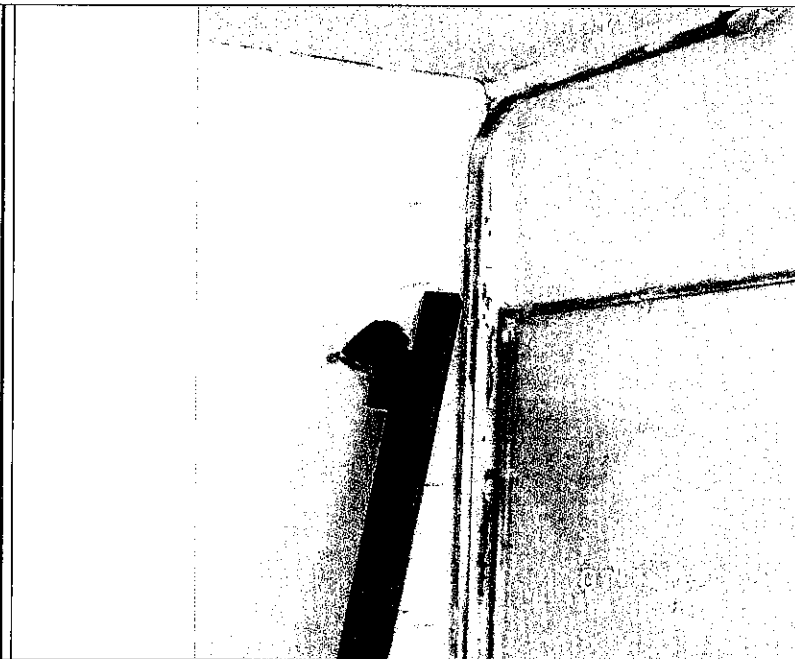
**Photograph 50** - 04/27/05 – Apartment Building (Building #19): Cracks at exterior 2<sup>nd</sup> floor porch's connection to main building

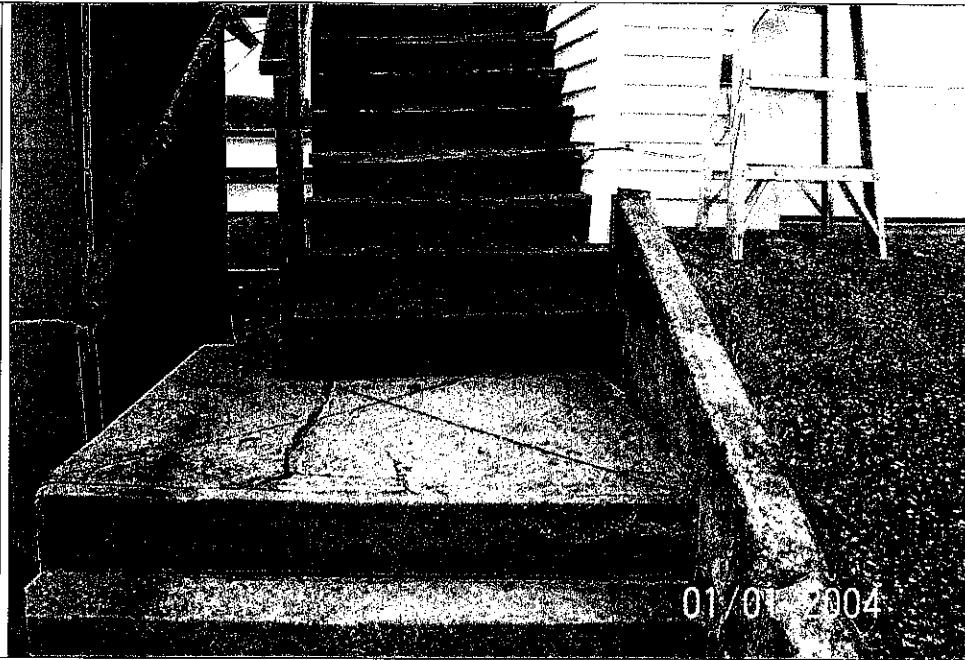
**Photograph 51** – 04/27/05 – Apartment Building (Building #19): Cracks in slab at exterior porch stair support; exterior porch stairs are leaning away from building

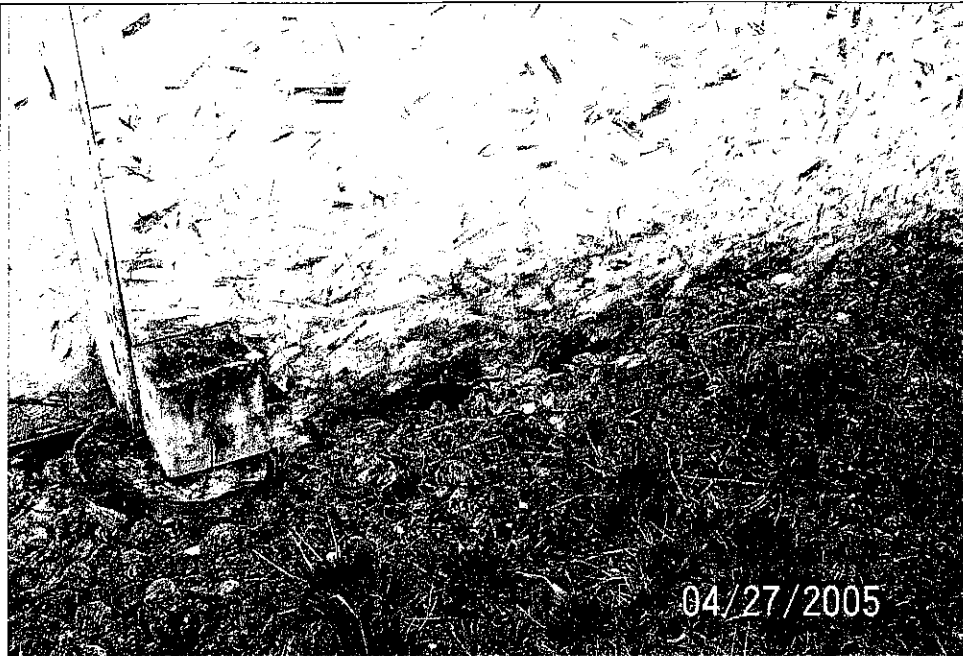
**Photograph 54** – 04/27/05 – Maple Hill (Building #20): Deterioration of exterior plywood

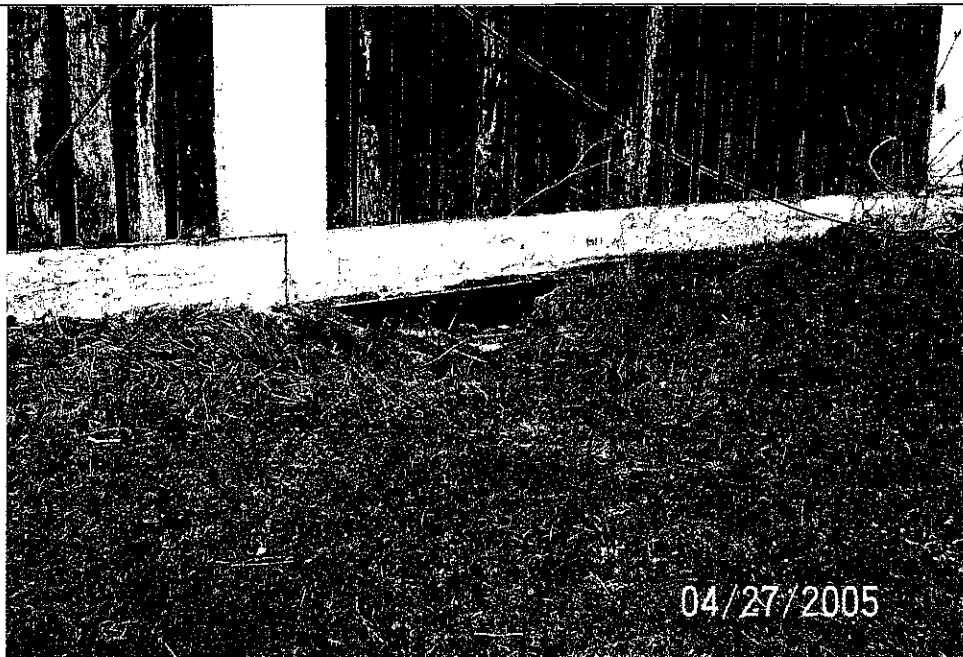
**Photograph 55** - 04/27/05 – Maple Hill (Building #20): Rear porch: erosion of soil at foundation

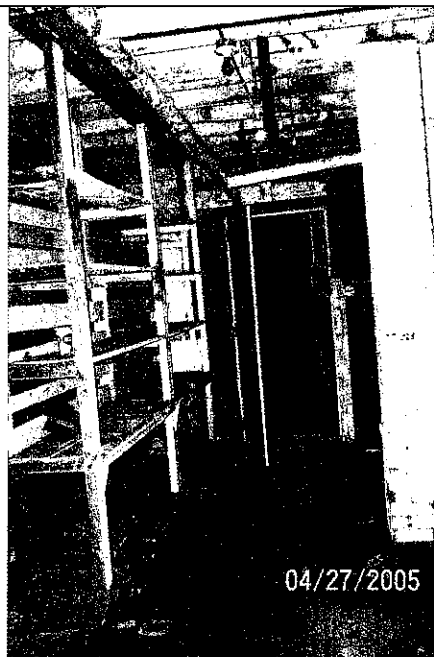
**Photograph 57** - 04/27/05 – Maple Hill (Building #20): Moisture in basement; patches of slab-on-grade
